# Technical Report

No. \_\_13523

LABORATORY AND FIELD TESTING OF THE

M1 EXHAUST DEFLECTOR

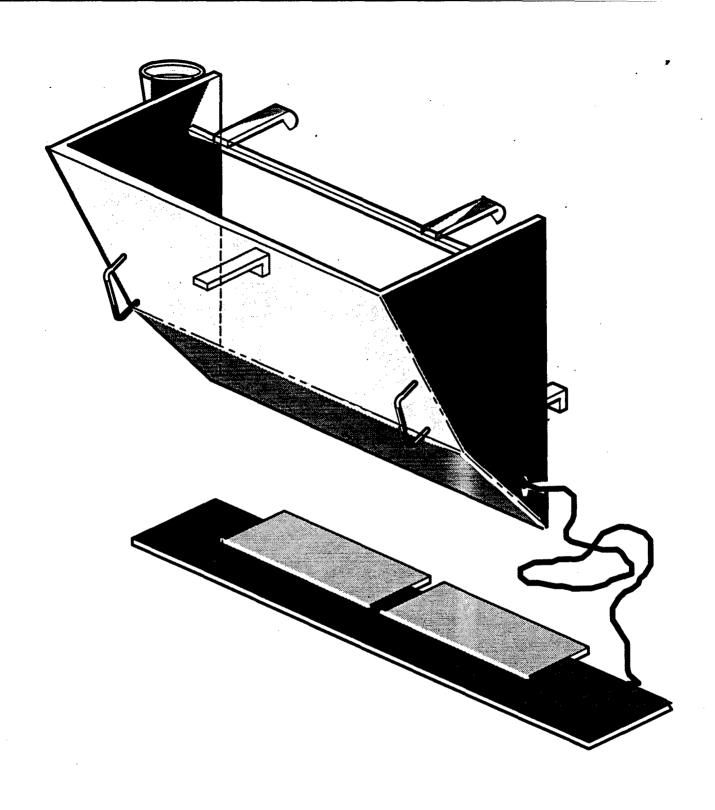
FIGURE 1 - M1 EXHAUST DEFLECTOR WITH PINTLE SHIELD

Field testing at APG resulted in no failures. The TACOM-designed deflector successfully withstood "G" loading of approximately 4.5 G's. The deflector did not detach from the tank grille from the

thrust of the engine exhaust. Also, the function of the deflector was not affected by vehicle vibration while towing. There were no failures due to heat damage.

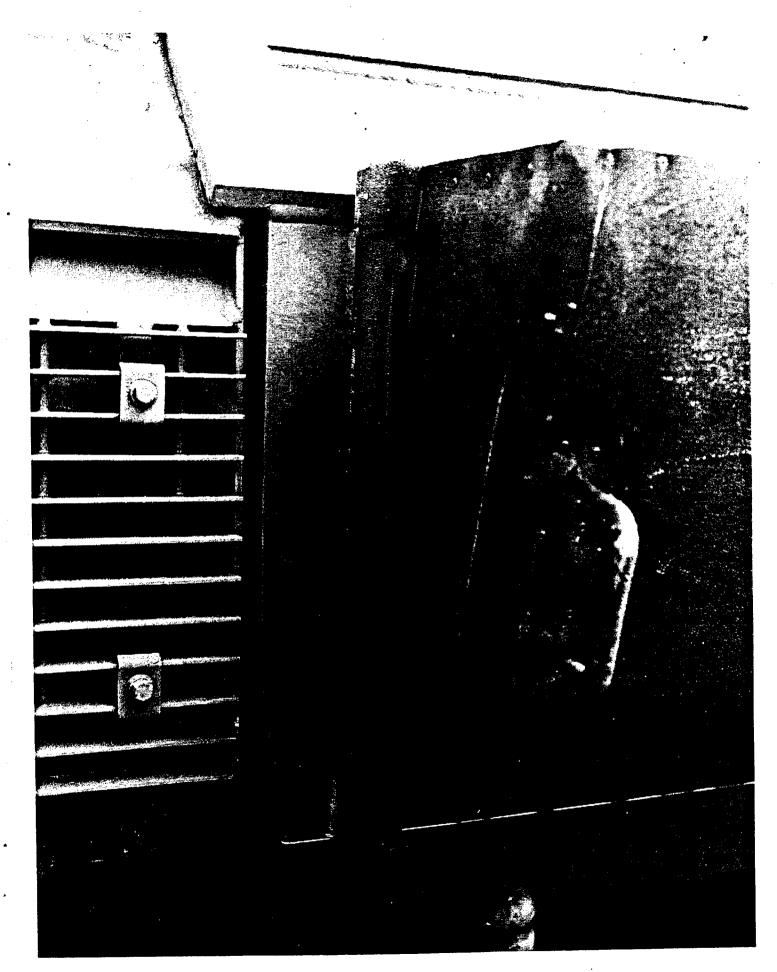
FIGURE 6 - THERMAL WRAP "TADPOLE" WITH INSTALLED M1 EXHAUST DEFLECTOR

During testing at APG, the radiant heat from the uninsulated flat surfaces of the deflector reached temperatures in excess of 550 degrees. These extreme temperatures made it difficult for the soldier to disconnect the towbar from the pintle after vehicle recovery and made removal of the exhaust deflector difficult after operations were complete. This deficiency was first detected during the testing of the exhaust deflector prototype and represented a MANPRINT deficiency.

While testing the deflector during towing operations at the Perryman test area at APG, the soldier was unable to remove the towbar without taking extraordinary precautions. The exhaust deflector alone did not provide enough protection from the radiant heat and from exhaust leakage that shot out from the left side of the deflector (directly above the pintle) during recovery operations and while at engine idle. The soldier had to lie on the ground to escape the exhaust that leaked from the side of the deflector while attempting to prepare the pintle for towbar attachment (Figure 3) or to connect or disconnect the tow bar to and from the pintle (Figures 4). The soldier's horizontal position was unsafe because the soldier was in direct line with the disconnected towbar, which weighs 340 lbs.

As part of the TACOM designed deflector, a thermal wrap was fabricated to reduce heat radiating from the deflector. The thermal wrap was fabricated in accordance with MIL-S-45351A(AT), which is the specification for Seal, Engine Shroud. The thermal wrap that was designed to reduce radiant heat (Figure 5), also included a tadpole one inch in diameter, 33 inches in length (Figure 6) that rivets into place along the left side of the

The thermal wrap fabric is made of a combination of aramid/glass and wire inserted cloth, with silicone rubber on the inside. The wrap is coated on the outside with aluminum pigmented silicone compound and painted black. The thermal wrap was attached to the exhaust deflector with stainless steel rivets and washers over one-inch, high-temperature, fiberglass insulation. The tadpole is packed with stainless steel wire mesh material, then wrapped with the thermal wrap fabric and is then riveted in place. Testing of the TACOM-designed deflector, with the thermal wrap in place, resulted in radiant temperatures of 180 - 350 degrees fahrenheit, a reduction of over 200 degrees fahrenheit from the temperatures attained during early testing without the wrap.

Further testing with the wrap and tadpole demonstrated a reduction of radiant heat and shielding of the exhaust leak to the left side of the deflector (above the pintle). The thermal wrap enhances the soldier's ability to safely complete the recovery operations, and remove the exhaust deflector.

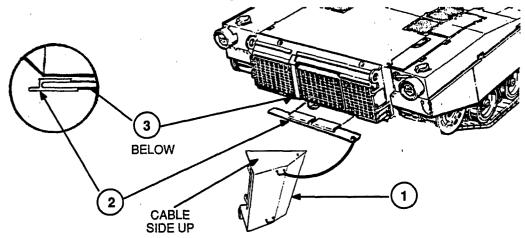
The exhaust deflector cannot be installed on vehicle rear grille doors having more than 12 vanes.

B. Before trying to install the exhaust deflector, count the number of vanes (1) in rear grille door (2) of the vehicle to be used for towing.

C. Position the exhaust deflector assembly (1) on the ground, on its side close to the towing vehicle, with the exhaust deflector assembly pintle shroud (2) cable side facing up as shown. Install pintle shroud (2) over vehicle rail (3) as shown and push shroud (2) firmly into place.
